## **October 23, 2018 - Tomahawk Cleans and Lines 100mm (4") Service Pipe to Building at CNL, in Chalk River, Ontario**

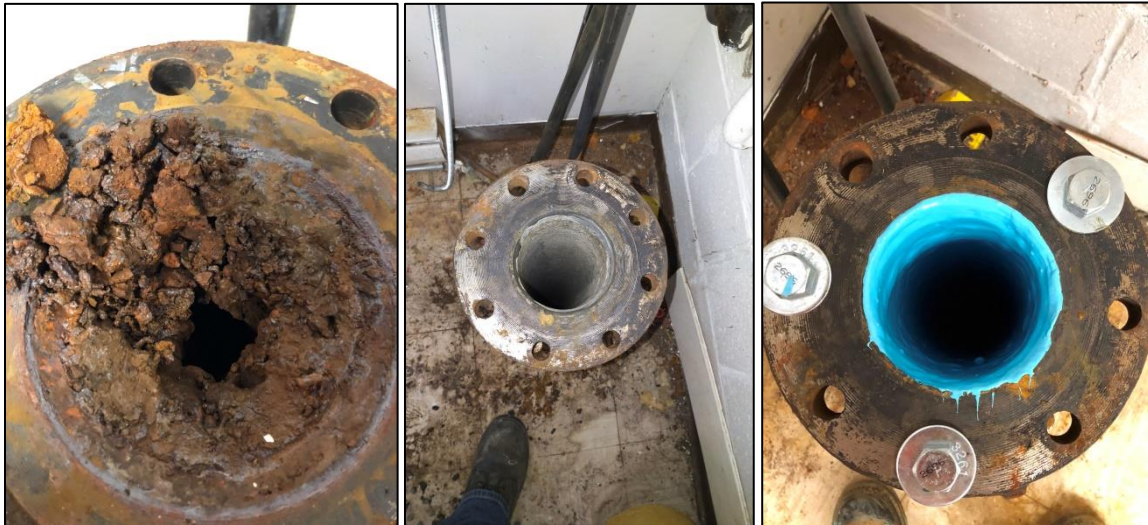
This project contained a 100mm (4") cast iron water service main into a building carrying both potable and fire water. The pipe was highly tuberculated causing flow rate and pressure concerns especially for fire-fighting purposes.

Pictures: Above left, interior (vertical) end of water service line before cleaning, center, after cleaning, right, after lining with Tomahawk BluKote™.

**Results:** Water flow rate was restored to original design, improving potable and fire flows. The pipe's useable life was extended by decades. Tomahawk's insitu pipe rehab process eliminated the need to dig-up the building's floor and foundation to replace pipe.

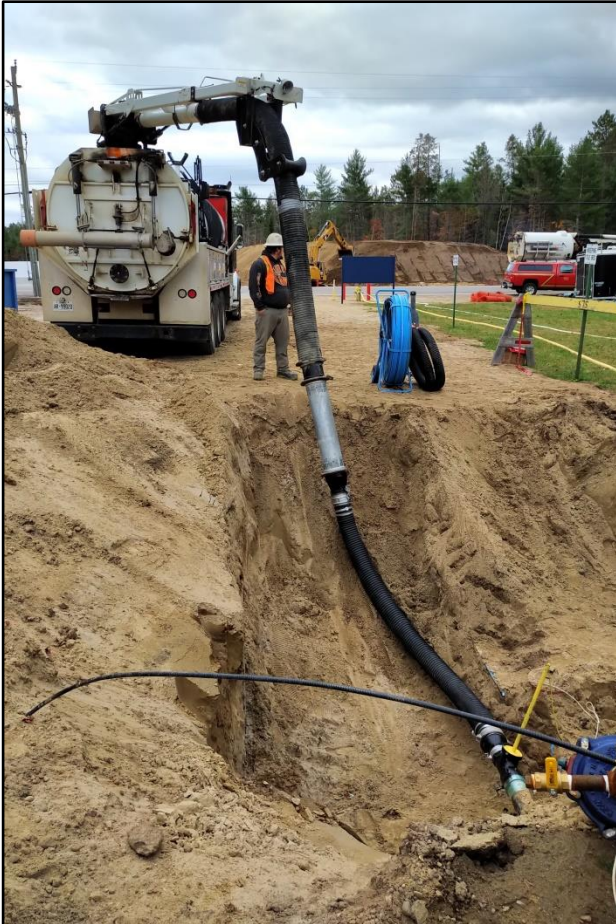
Pictures: Above left, cleaning operations outside of building, above top right, exterior horizontal end of pipe after cleaning, lower right, after lining with Tomahawk BluKote™.
