August 25, 2020 – Envirologics CEL (Clean, Evaluate and Line) of Watermain in Boucherville, Quebec

Pre-Project Condition:

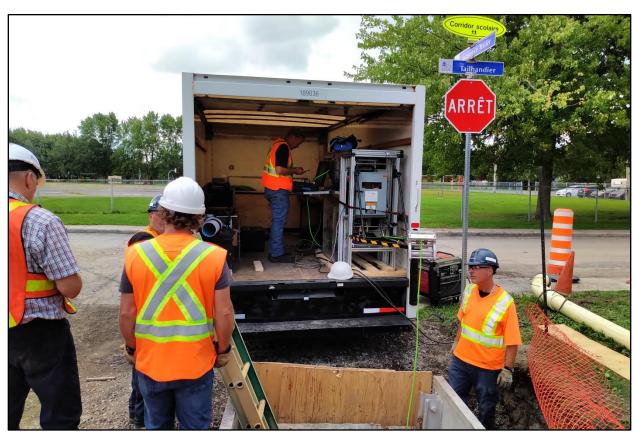
Above, performing RFEC evaluation of watermain in Boucherville, Quebec.

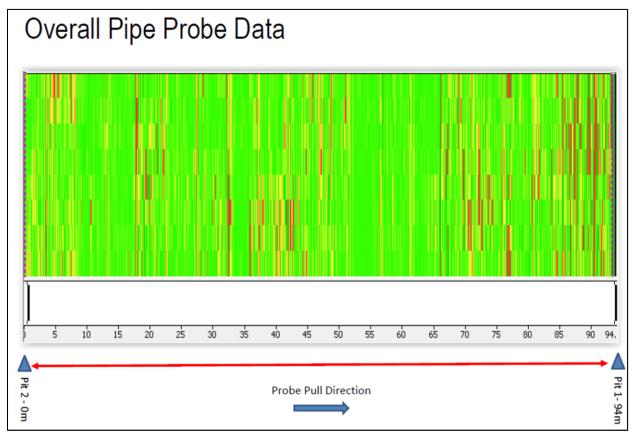
Above, Raw evaluation or remaining wall thickness data of pipe using the Envirologics Detective RFEC probe.
