# Same day return to service

Bitumen lining removal and application of water quality lining in 1960's era cast iron water pipe in Saint John, New Brunswick

BY BRIAN THOROGOOD, P.ENG

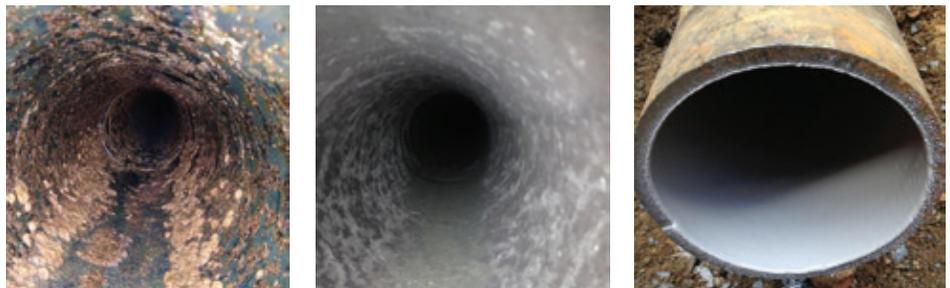
**Left: 6-inch, 435 foot CI pre-cleaned pipe prior to Tomahawk cleaning, corrosion and bitumen seen. Centre: pipe after Tomahawk cleaning including removal of loose graphic corrosion, light gray sites. Right: after pipe lining by Trenchless Solutions.**

Trenchless Solutions then contracted Envirolitics to remove the bitumen from the 435 foot pre-cleaned pipe along with a second 357 foot section. Once on-site, Tomahawk quickly removed the corrosion and bitumen from the 435 foot pipe in 2 ½ hours. The pipe was left in a clean and dry state, ready for lining. The results generated excitement by those watching including a lining crew member who

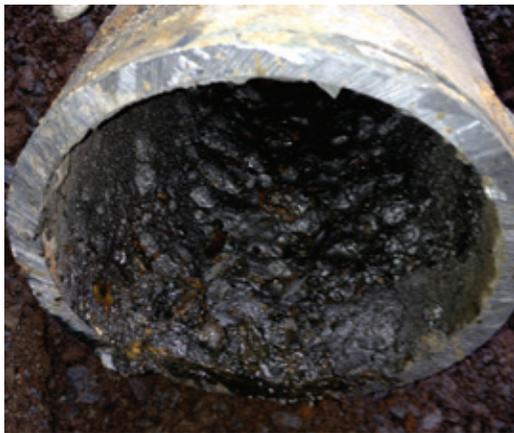
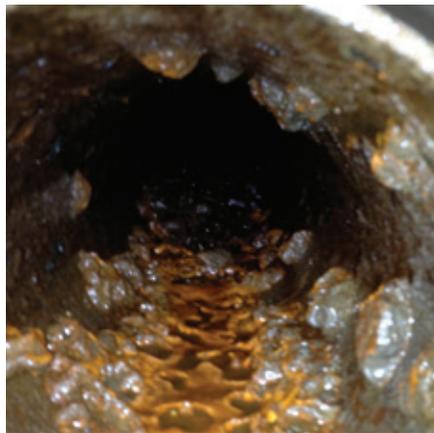
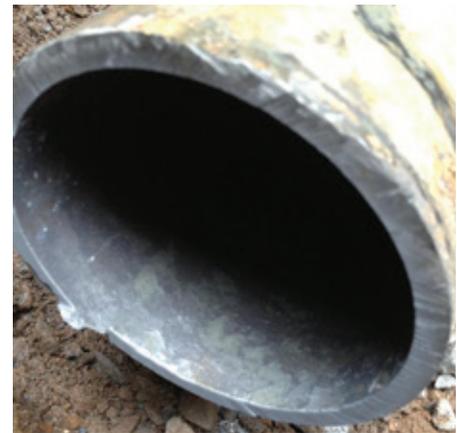
**Left and centre: 6-inch, 357 foot CI water main prior to Tomahawk cleaning. Right: same pipe after cleaning.**

On the following day, the 357 foot section was cleaned by Envirolitics in under 3 ½ hours. This pipe had not been pre-cleaned thus requiring both tuberculation and bitumen removal. This pipe was cleaned and lined under “same day return to service” conditions as no service bypass was in place. The water main was taken off line, cleaned, inspected, lined, flushed and reinstated by evening under a “boil water advisory”. The advantages of same day return to service include lower project cost and timing along with a significant
