CLEANING TO LINING: ENVIROLOGICS TAKES TOMAHAWK TO NEXT STEP

BY CHAD FRASER, CUI

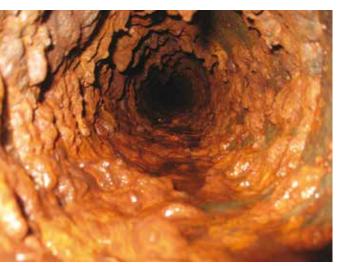
after relining, using the **Tomahawk** pipe cleaning system in combination with a sprayin-place liner from 3M.

Before and

In November 2014, the pair cleaned and lined 1,000 feet of eight-inch cast-iron pipe and 614 feet of six-inch cast-iron pipe in Victoria, B.C. And in April 2015, they worked on 1,463 feet of eight-inch cast-iron pipe and 869 feet of six-inch pipe in Vancouver.

After Tomahawk cleaned and prepped the pipes, Canadian Induracoat followed up with its Scotchkote 2400 spray-inplace liner.
